PARKS AND RECREATION COMMISSION AGENDA REPORT

SUBJECT: REVIEW OF TALBERT REGIONAL PARK FINAL HABITAT RESTORATION PLAN

Figure 1: Talbert Regional Park Project Site

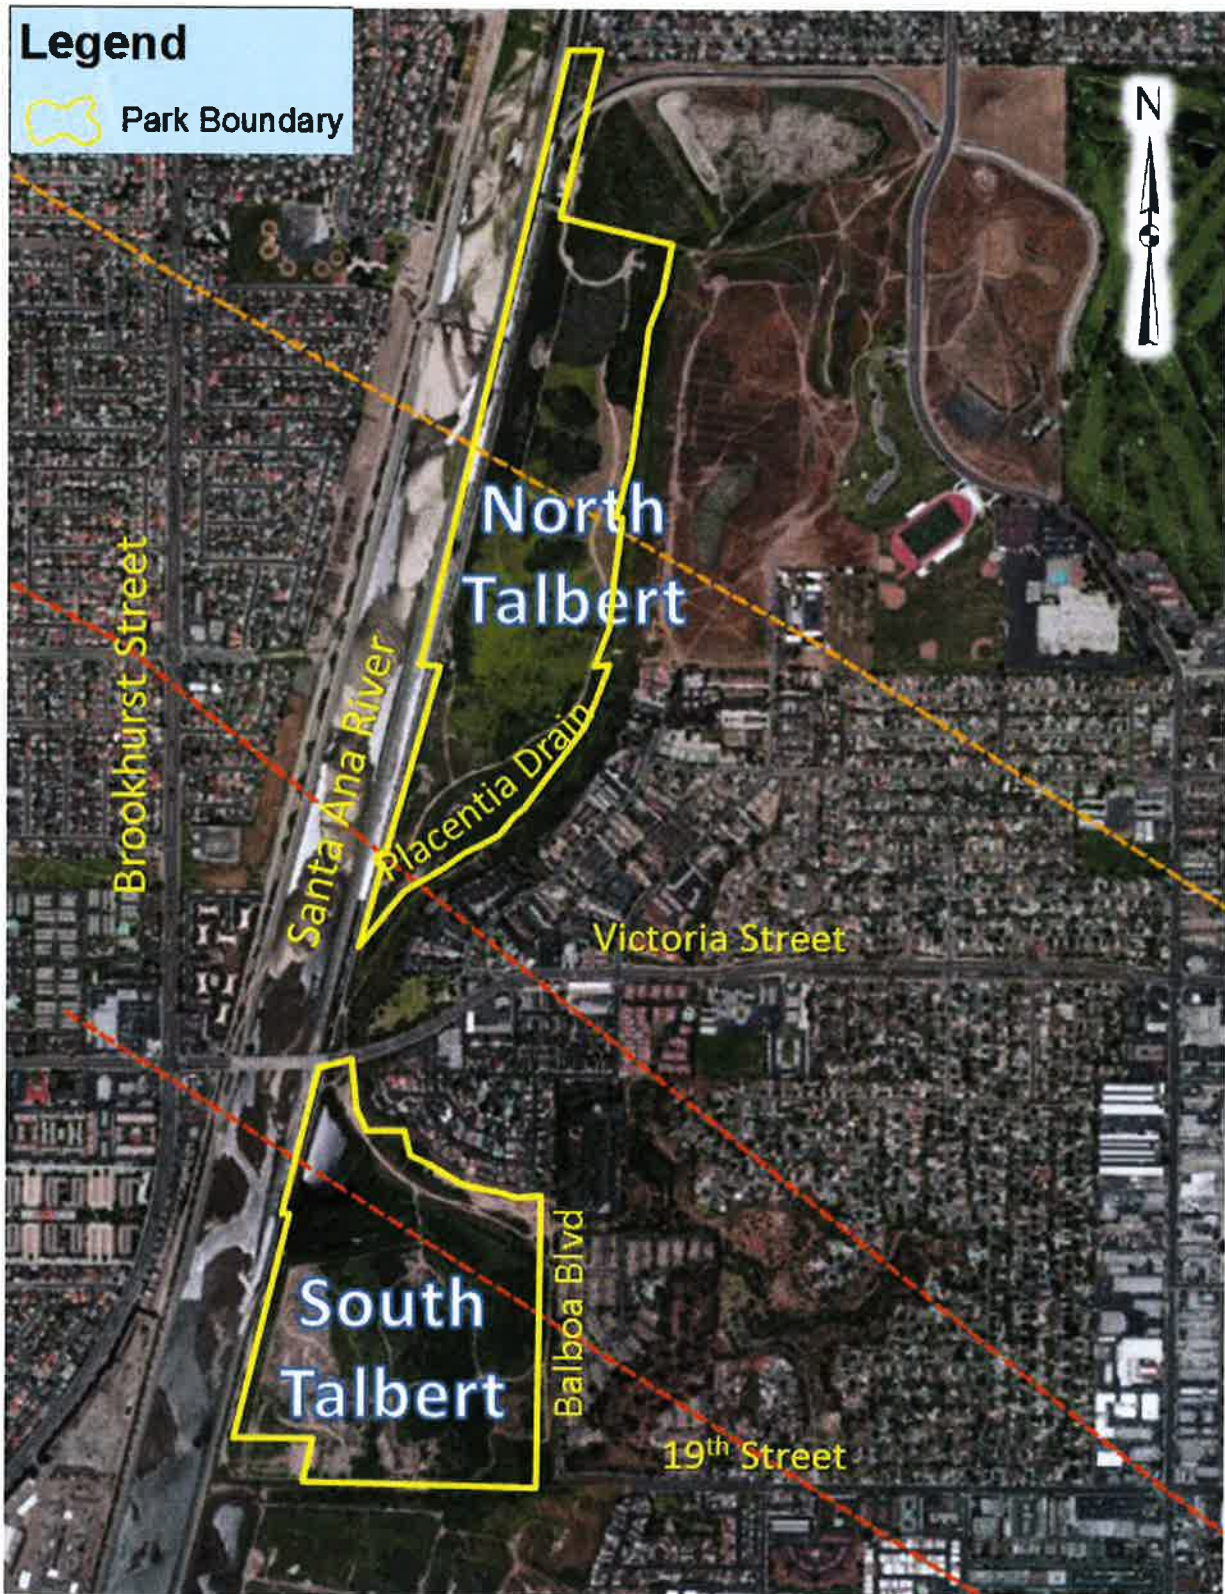
Figure 4: Earthquake Faults
(Source: USGS 2014)

- Figure 4 depicts earthquake faults at the park site. According to the U.S. Geological Survey (USGS) database of earthquake faults, three faults associated with the Inglewood-Newport-Rose Canyon fault zone cross beneath Talbert Regional Park and the adjacent cities of Newport Beach, Costa Mesa, and Huntington Beach. The faults lines are oriented in a northwest/southeast direction.

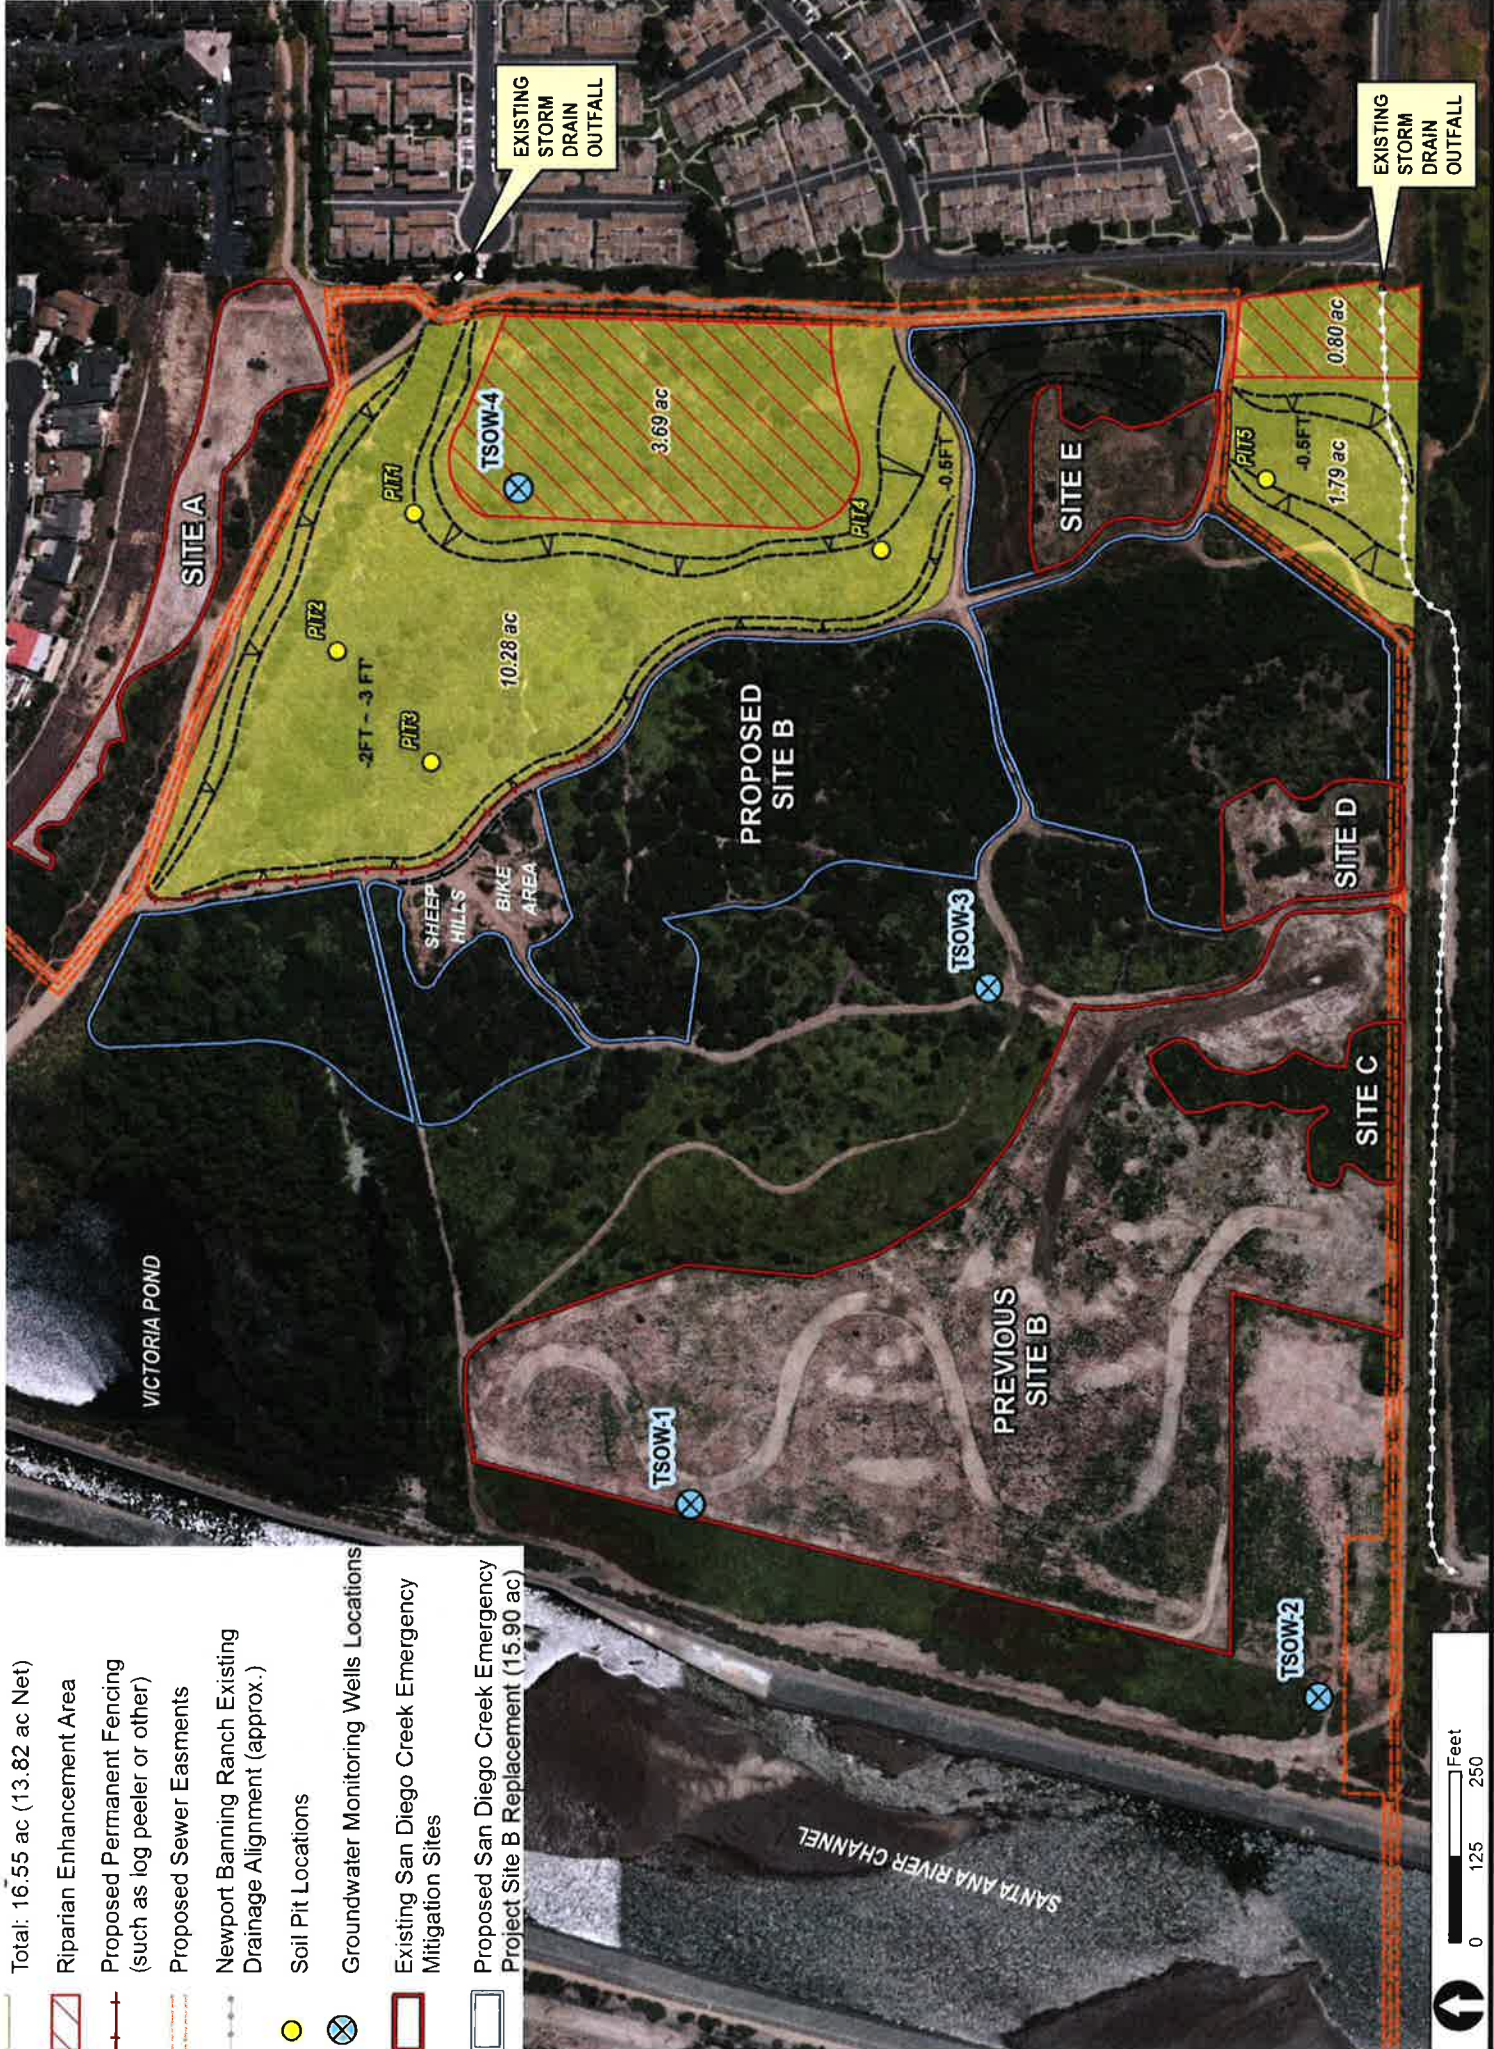
- Total: 16.55 ac (13.82 ac Net)
- Riparian Enhancement Area
- Proposed Permanent Fencing (such as log peeler or other)
- Proposed Sewer Easements
- Newport Banning Ranch Existing Drainage Alignment (approx.)
- Soil Pit Locations
- Groundwater Monitoring Wells Locations
- Existing San Diego Creek Emergency Mitigation Sites
- Proposed San Diego Creek Emergency Project Site B Replacement (15.90 ac)

There are five existing habitat restoration/mitigation areas at South Talbert. These mitigation areas were created by Orange County Public Works (OCPW) to compensate for (riparian) impacts associated with OCPW San Diego Creek Emergency Repairs and Peters Canyon Channel Bikeway Projects. The five mitigation areas are Sites A, B, C, D, and E. See Figure 9 for OCPW mitigation sites at South Talbert.

At Site A, restoration and monitoring of coastal sage scrub habitat is being done by OCPW. At Sites B, C, D, and E, restoration and monitoring of southern willow scrub habitat is being done by OCPW. Mitigation monitoring reports have been prepared annually since 2010 for these areas (Dudek 2014). As a result of the difficulty in establishing riparian habitat in the southwest part of South Talbert, OCPW is in the process of designating a new area for riparian habitat restoration. This new area is called "Proposed Site B". OC Parks is working closely with OCPW in coordinating restoration efforts at Talbert Regional Park.

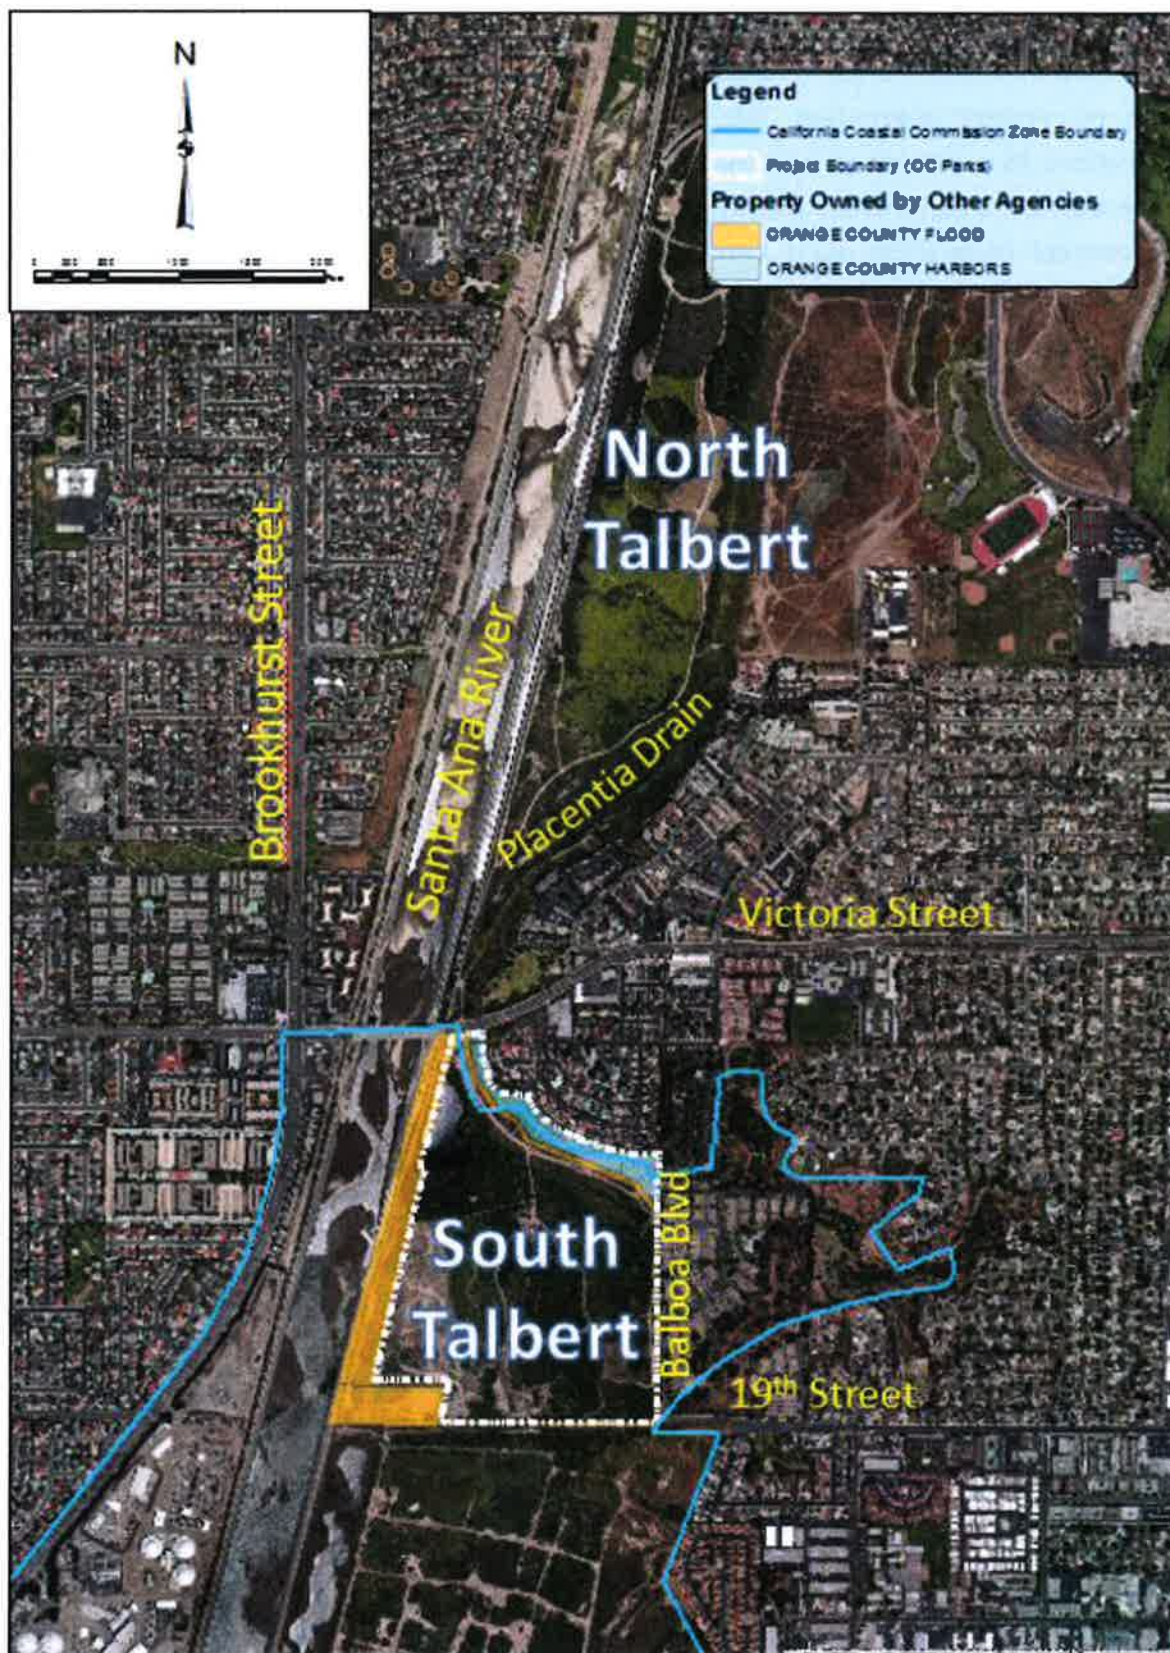
Figure 21: Coastal Commission Jurisdiction

10. Permitting – There is no LCP for Talbert Regional Park and South Talbert falls within the Coastal Zone boundary and the California Coastal Commission's jurisdiction. The boundary of the Coastal Zone was created in 1972 and modified in 1976 to include portions of the Santa Ana River lowlands south of Victoria Street, a majority of Canyon Park to the east, and portions of the adjacent bluff properties (EDAW 1991). For a map of the California Coastal Commission's jurisdiction, see Figure 21.

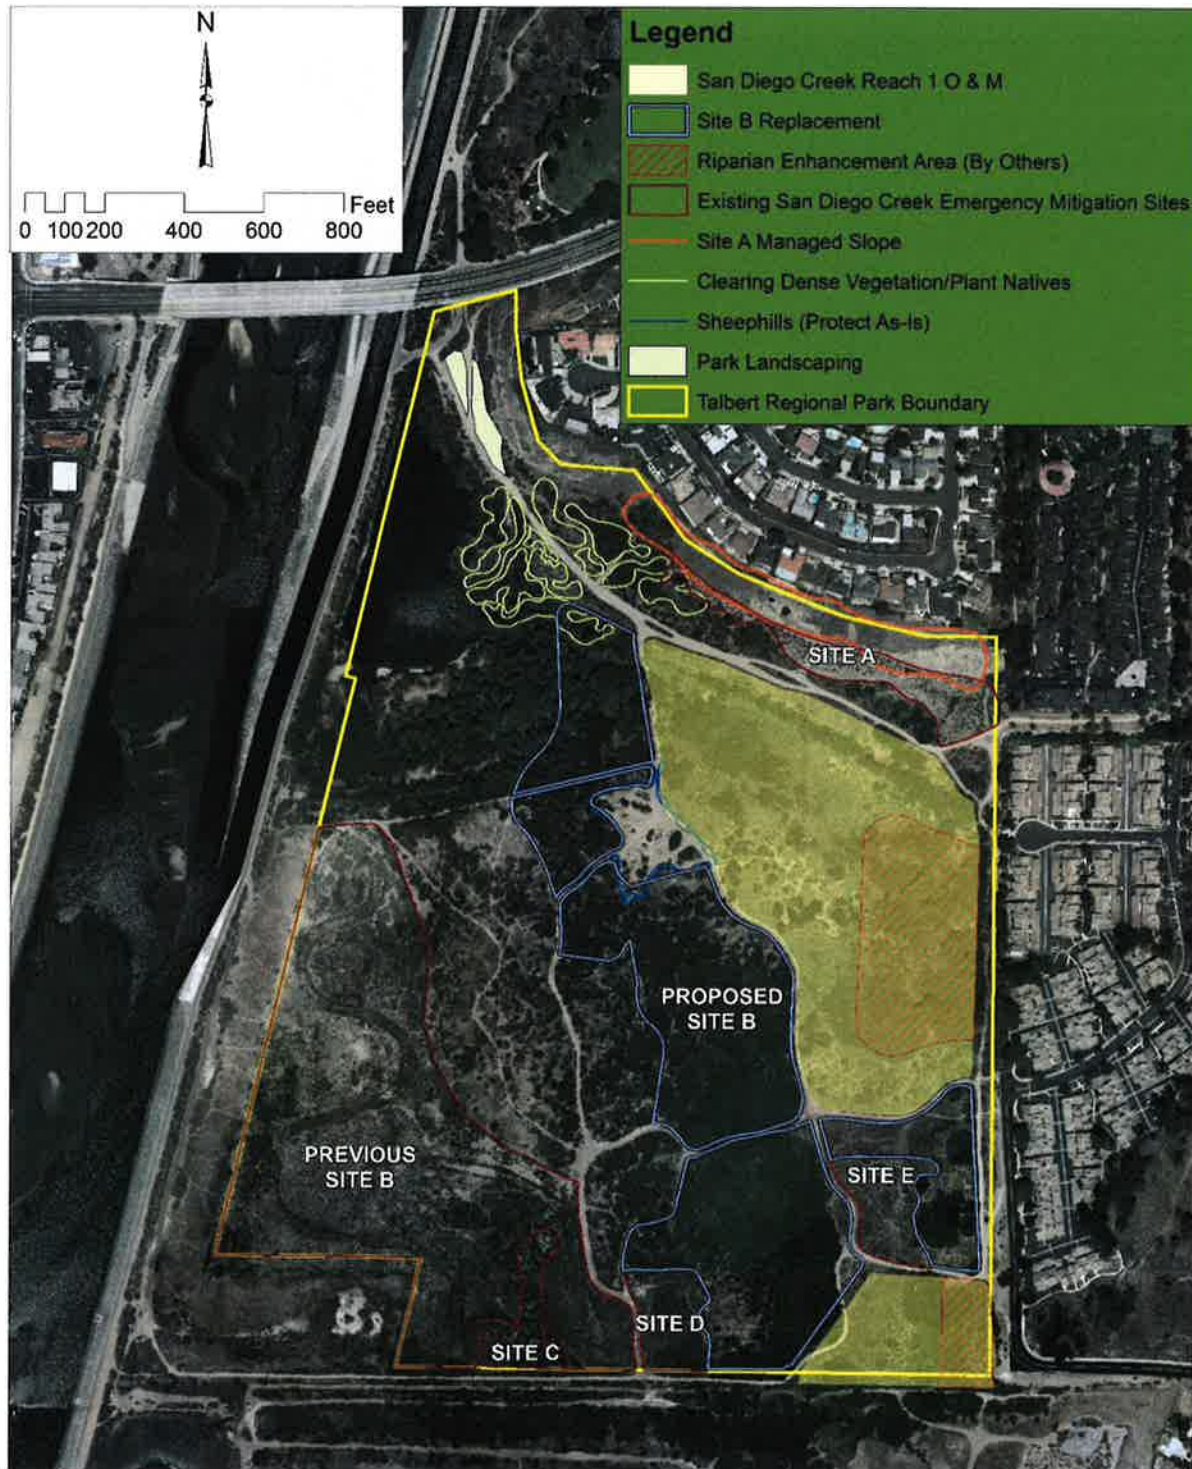
Figure 23: Alternative 1

- No grading, minimum changes to the site only
- Remove non-natives
 - Placentia Drain at North Talbert
 - Throughout the site at South Talbert
- Reserve areas for salt marsh and freshwater plantings
- Do not alter restoration sites (B thru E)
- Plantings at the top of bluffs only (Site A)
- Improve the main entrance access at Balboa Boulevard
- No existing trail alterations, add interpretive signs only
- New loop trail around Victoria Pond
- No additional parking, kiosks, or overlooks
- No alterations to Sheephills /protect “as-is”

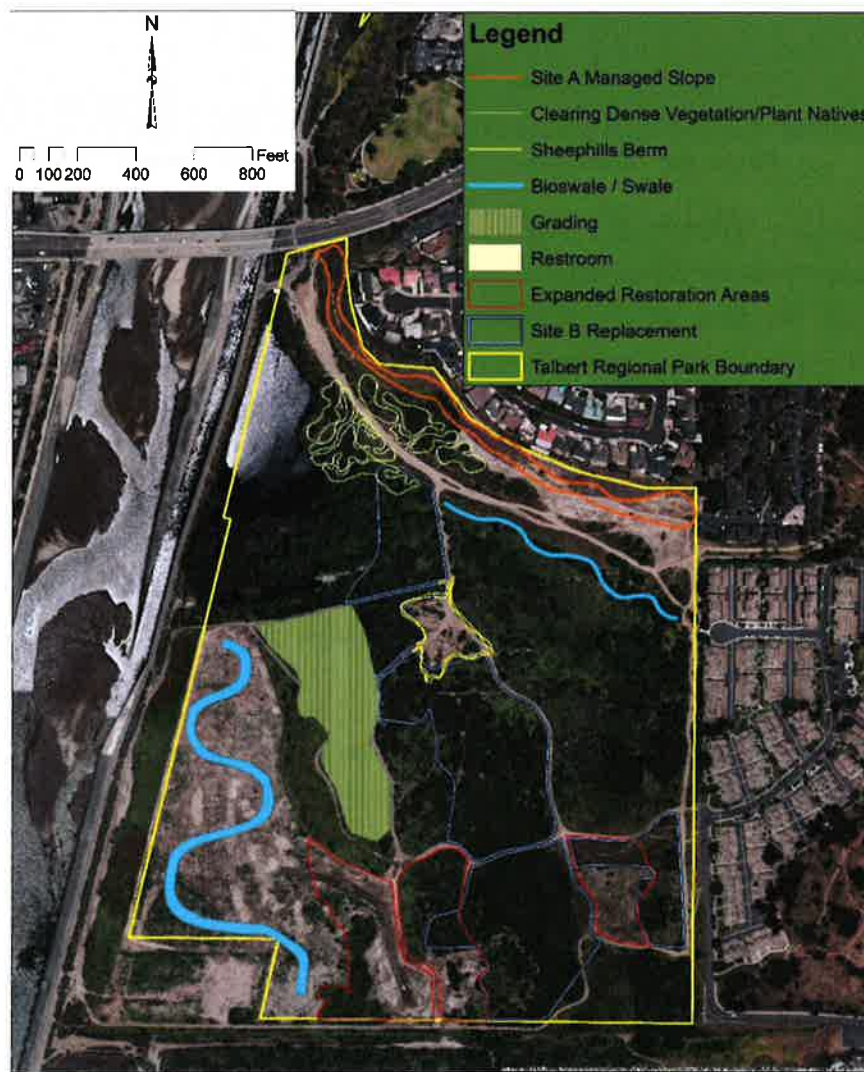
Figure 25: Alternative 2

Restoration components for Alternative 2 are shown in Figure 25. An overview of access improvements is shown in Figure 26. This alternative represents a mix of features proposed for the minimum and maximum alternatives. Under this alternative a moderate amount of site improvements and alteration would occur. Changes to the site would include removing non-native vegetation, plantings of coastal sage and riparian tree species, expanding the existing mitigation/restoration areas (increase coverage in square feet or acres), deepening the swale in the southwest corner by excavation, and plantings of salt marsh vegetation. Other changes include clearing out dense vegetation areas, adding ADA access ramps and trail amenities such as signs and kiosks, delineating trail edges, making improvements at the main Balboa Boulevard entrance, and trail coordination with the 19th Street bike trail project on the southern boundary of South Talbert. Design components proposed for this alternative are listed below:

- Expand the acreage and tree canopy cover in restoration sites C, D and E
- Non-native removal and plantings of riparian habitat
 - Placentia Drain at North Talbert
 - Throughout the site at South Talbert
- Grading the transitional slope for salt marsh wetlands
- Add an ADA compliant loop trail
- Remove the fence around the pond or reconfigure it to allow greater access
- Pier (option) over Victoria Pond
- Stock the pond with fish
- Sheephills will have perimeter grading only for pedestrian traffic

Overall Public Access elements for Alternative 2 are shown in Figure 25 in Section 3.5. This alternative represents a mix of features originally proposed for the minimum and maximum alternatives. Under this alternative a moderate amount of site access improvements would occur

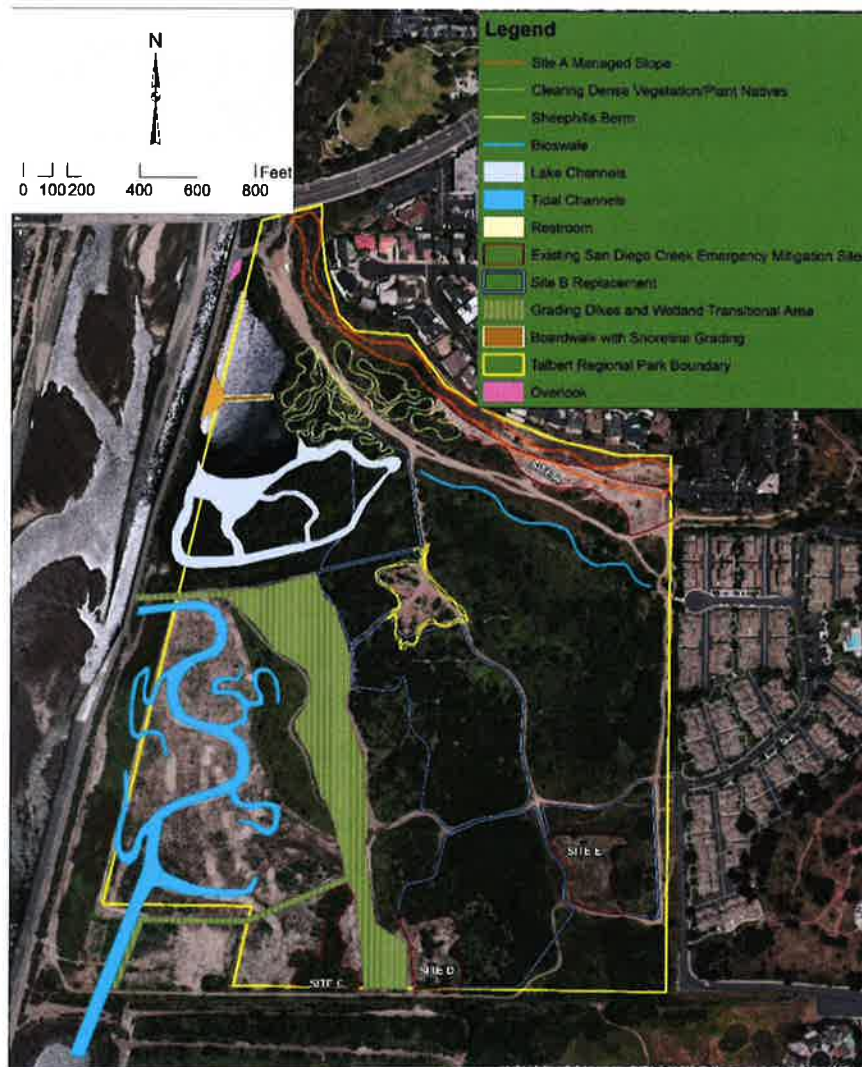
Figure 27: Alternative 3

Restoration components for Alternative 3 are shown in Figure 27. Access improvements are shown in Figure 28. This alternative introduces the maximum amount of site improvements and alteration to address restoration needs and maximize habitat diversity at the park. Changes to the site would include channel excavation for salt marsh habitat, excavation along the southern edges for expansion of the pond, planting coastal sage along the bluff top, restoring riparian habitat, and bioswale/drainage design. Other changes include clearing out dense vegetation areas, adding ADA access ramps and trail amenities such as signs and kiosks, delineating trail edges, making improvements at the main entrance and trail coordination with the 19th Street bike trail project on the southern boundary of South Talbert. Design components proposed for this alternative include:

- Grade existing channel depression in southwest area, add new feeder channels
- Grade drainage channel east of pond and naturalize it
- Non-native removal and plantings of riparian habitat
 - Placentia Drain at North Talbert
 - Throughout the site at South Talbert
- ADA compliant trails
- Boardwalk over Victoria Pond
- Small footbridges over peripheral waterways connecting to Victoria Pond
- Sheephills perimeter grading only for pedestrian traffic

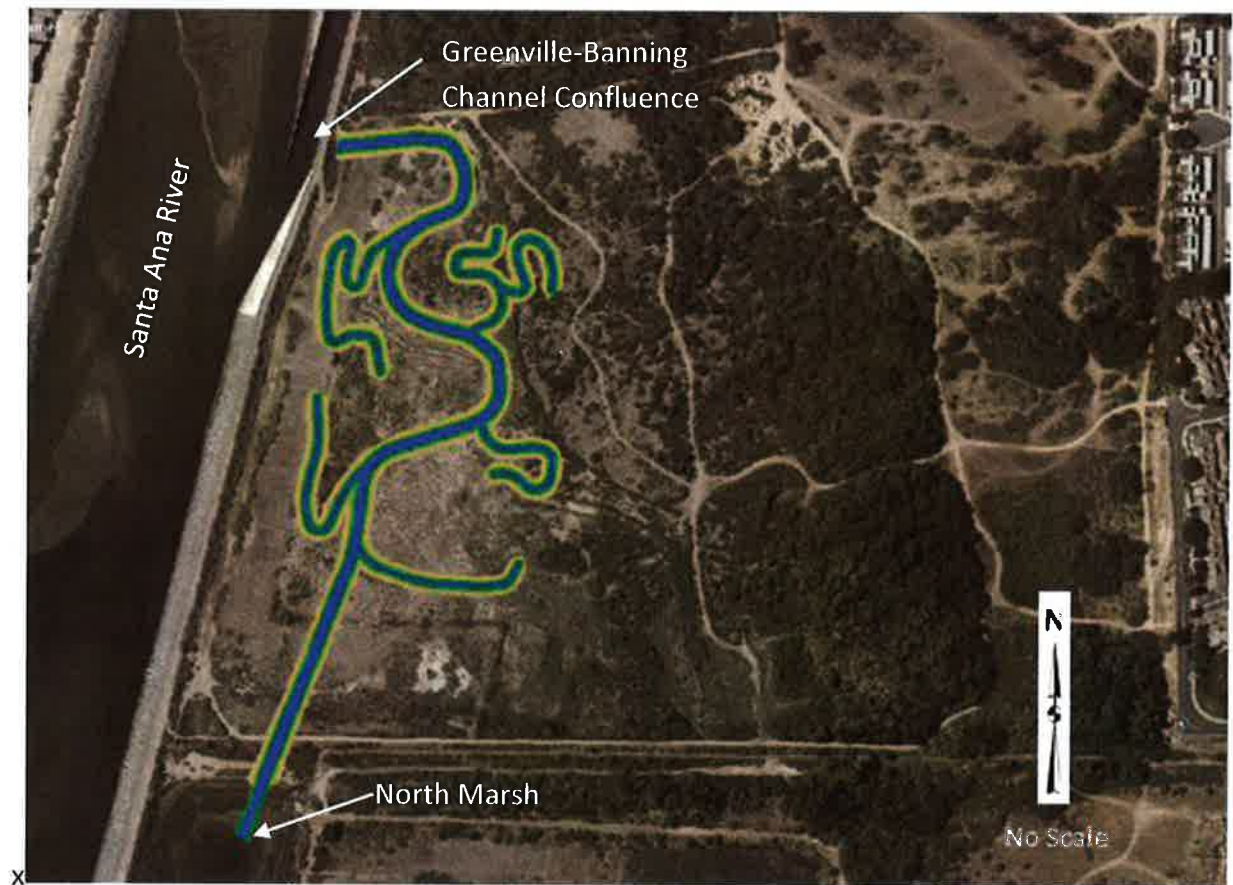
Figure 29: Proposed Tidal Connection and Tidal Channels for the Salt Marsh

As shown in Figure 29, a tidal connection is proposed at the USACE North Marsh project or near the confluence of the Greenville-Banning Channel (GBC) and Santa Ana River. Tidal flow could be brought into the park from either location - the GBC/Santa Ana River or North Marsh – and be conveyed through either an open channel or a large culvert. Tidal flow would then be conveyed to the southwest portion of the park through a main channel and small feeder channels branching off the main channel. The water level of the channels will fluctuate with the ocean tide conditions. Therefore, during low tide cycles, the water level of the channels will be low; during high tide cycles, the water level of the channels will be high.

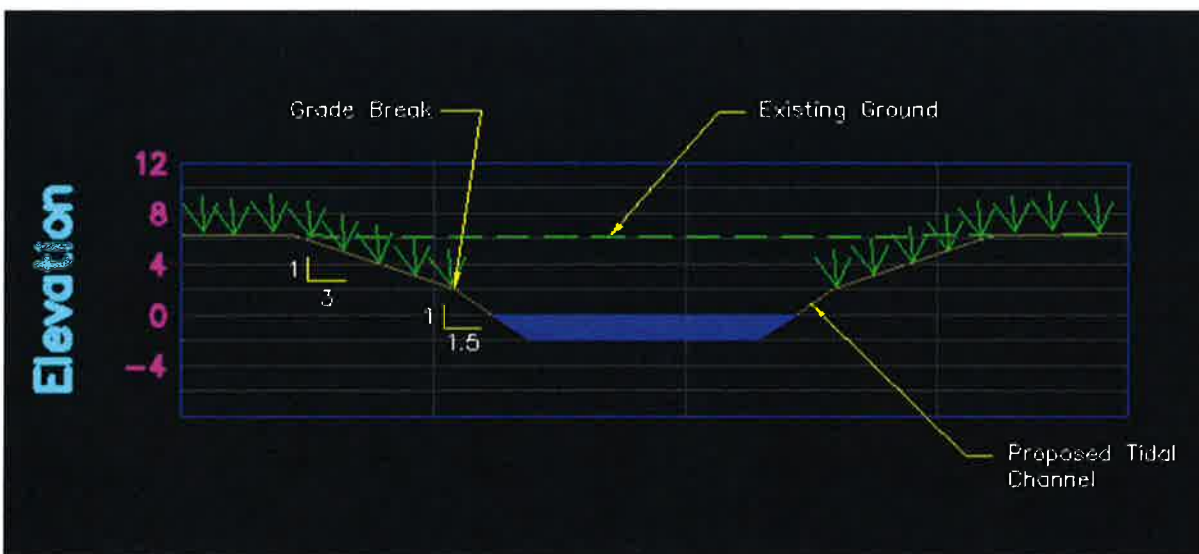
Figure 30: Typical Cross-section of Tidal Channel

Alternatively, the existing ground surrounding the tidal channels could be excavated down from the existing elevation of +6 feet NGVD to an elevation between +2 and +3 feet NGVD. This would create a fully functioning tidal salt marsh that more closely resembles existing salt marshes in the Park vicinity such as North Marsh, Semeniuk Slough, and Huntington Beach Wetlands (Talbert, Brookhurst and Magnolia Marshes). The trade-off however, is that as sea level and high tides increase over time, the salt marsh will become submerged, i.e. the subtidal channel area will expand and the marsh vegetation area will decrease. To lower the elevation of the adjacent ground would also require more substantial excavation which will increase the cost of the project. The decision to excavate only tidal channels or the entire southwest area can be evaluated further when OC Parks selects a preferred alternative.

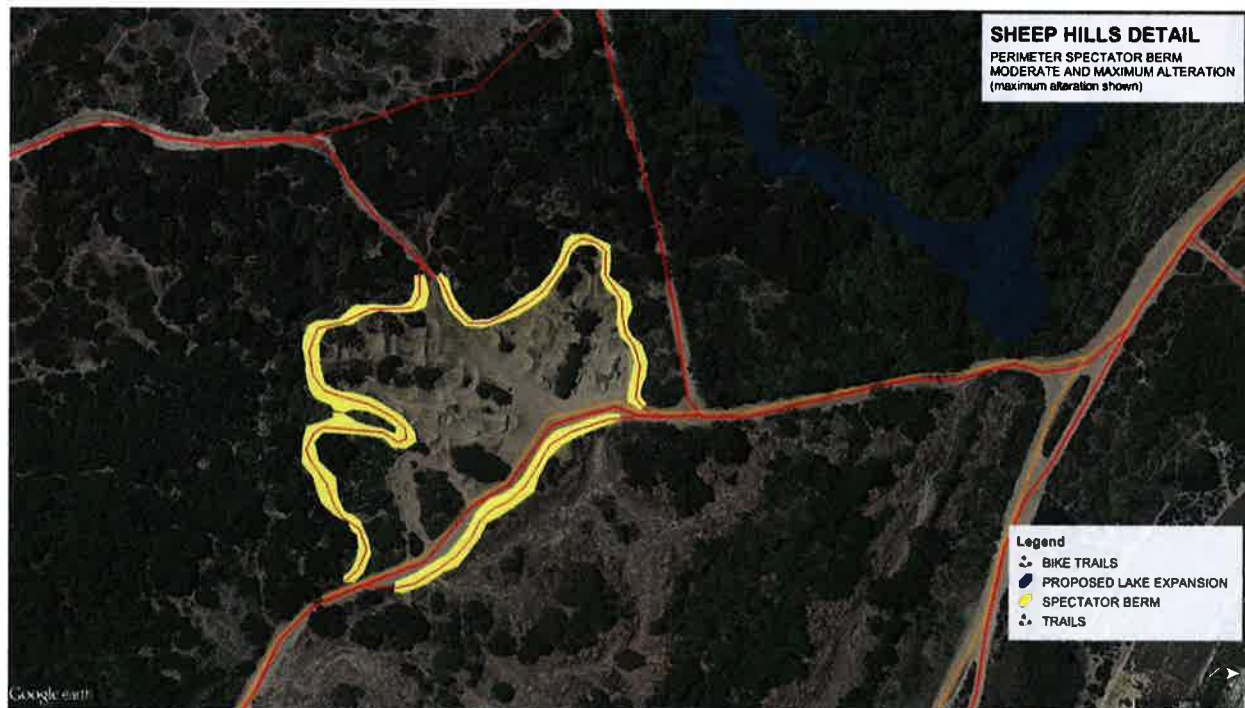
Figure 41: Alternative 2 Sheephills Access

Figure 41 shows Sheephills access improvements under the moderate touch alternative in planview. In this alternative, the edge of Sheephills is proposed to be defined by a “spectator berm,” providing viewing of the BMX activities by visitors and safe separation between the visitors and more active users of the Park, while placing a defined and final limit on the total area of Sheephills. Figure 42 shows Sheephills access improvements in cross-sectional view.

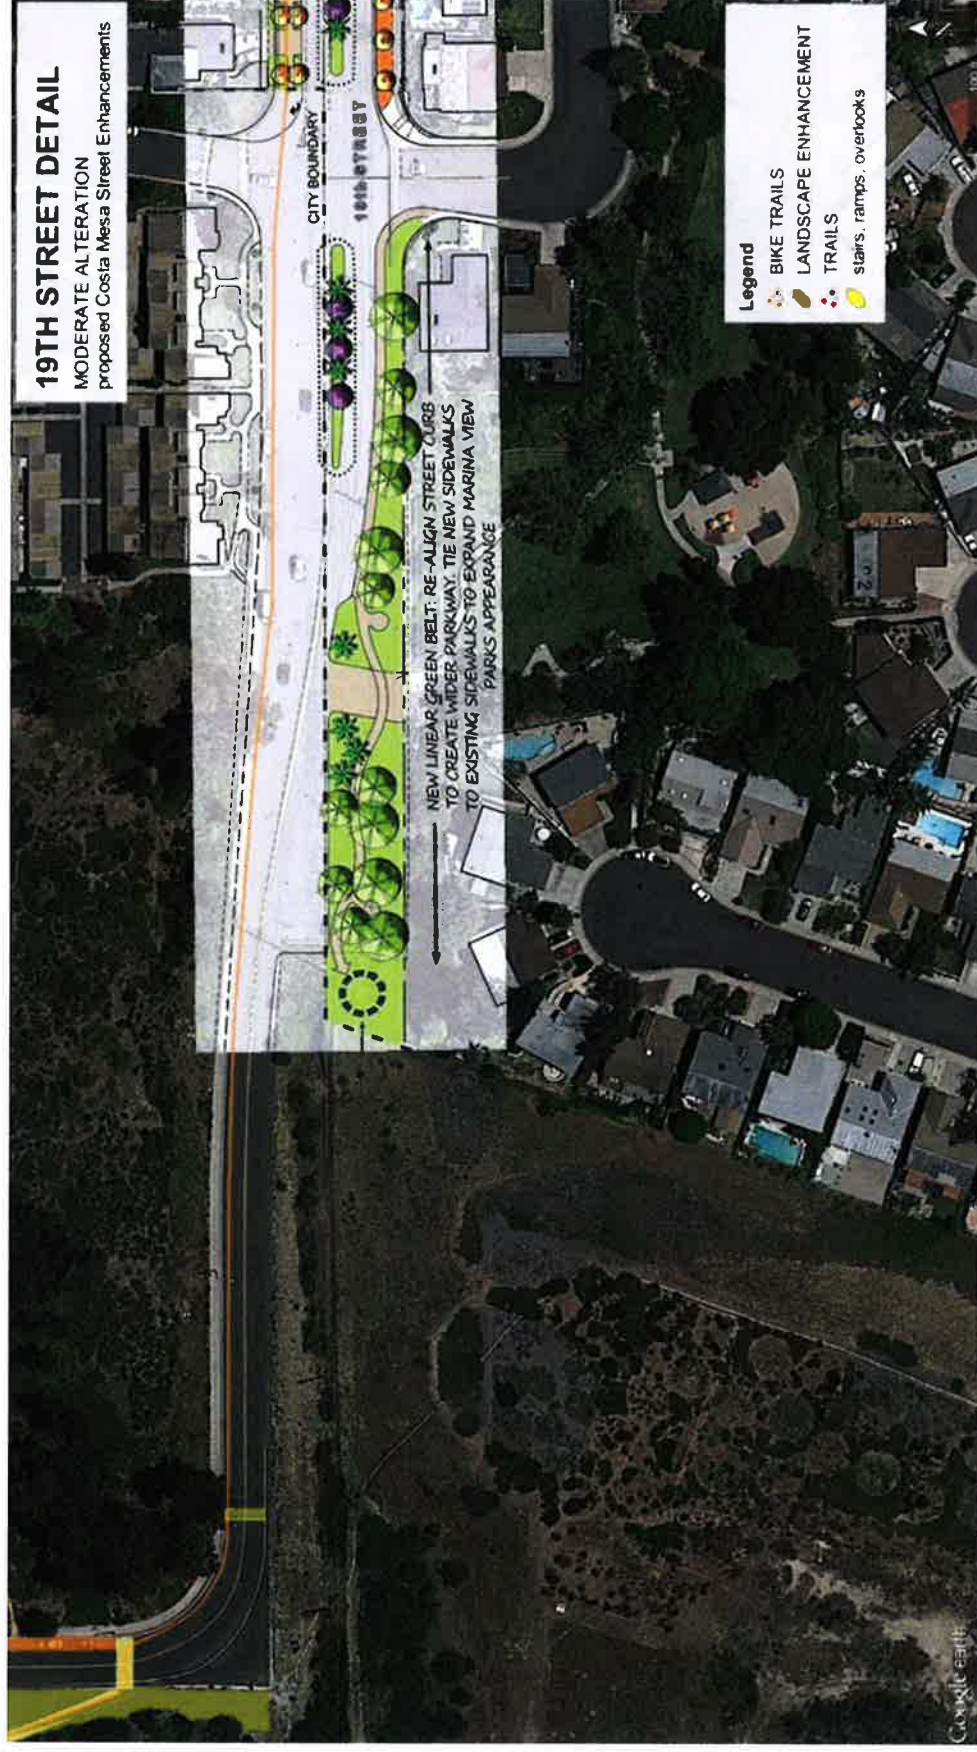
Figure 43: 19th Street Access Improvements

The moderate alternative integrates with Costa Mesa’s bicycle improvement project. It includes a linear park where the existing paved area on 19th Street is widest. This concept also provides for the extension of the proposed north side bicycle path to a crossing near the proposed Balboa bicycle access ramp. Figure 43 shows 19th Street access improvements.

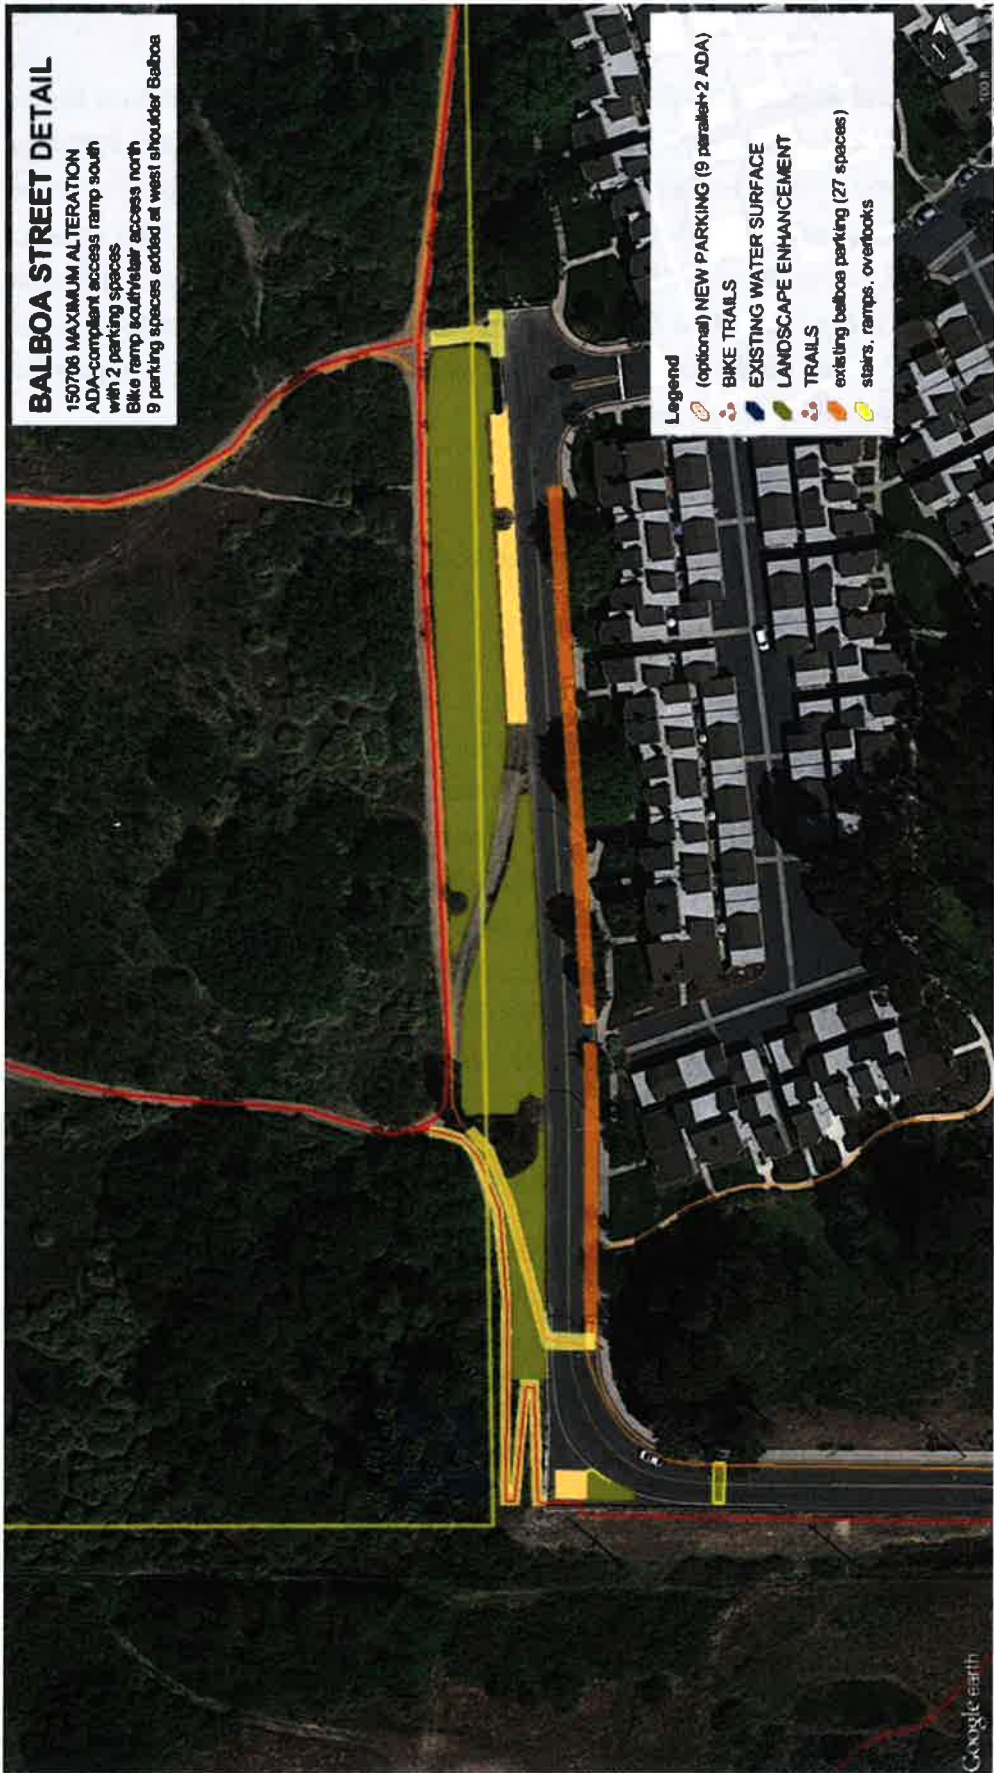
Figure 45: Alternative 3 Balboa Access Improvements

As in Alternative 2, the current stair access at the north terminus of Balboa Boulevard would be improved, as would the existing service vehicle access from Balboa. The balance of the steep and currently eroding fill slope will be re-vegetated for slope stability and erosion control, and to provide visual separation between the road and the Park, while framing the entrance and access points along Balboa.

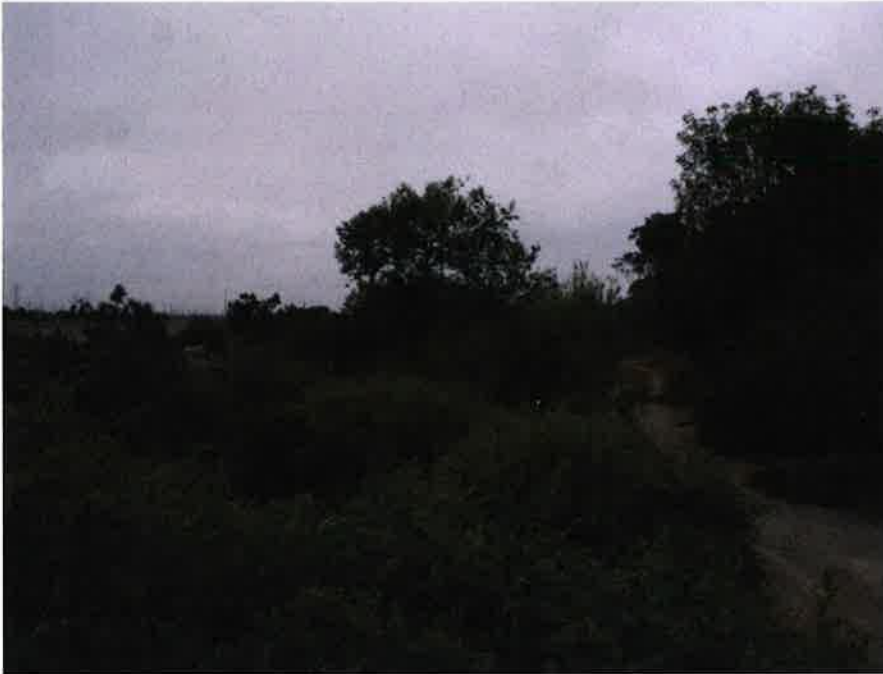
Photo 1. Photo depicts Quailbush Scrub off of Victoria Street on the east side of the Santa Ana River channel. Photo facing north. Corresponds to Photo Point 1.

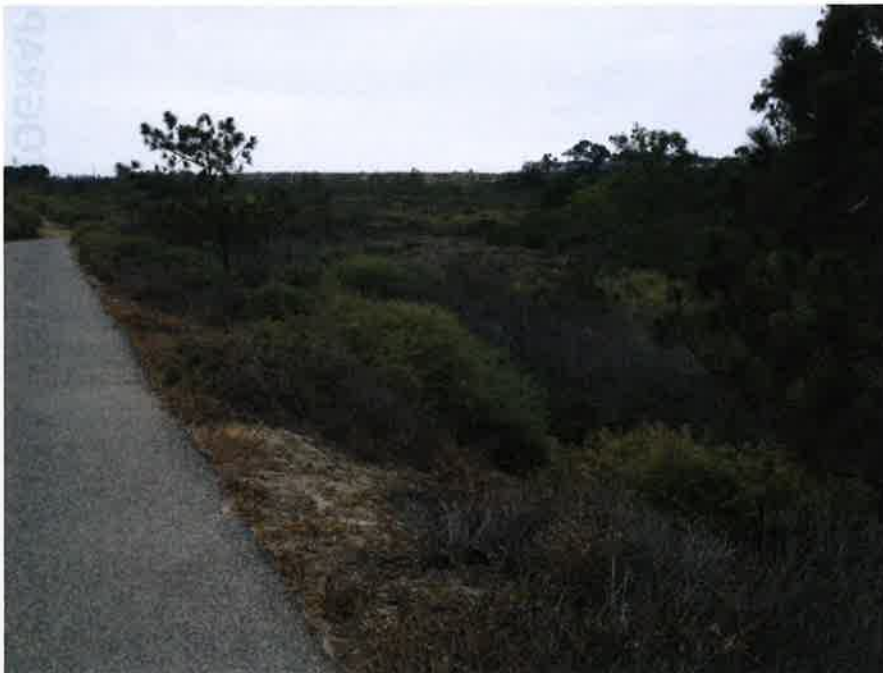
Photo 2. Photo depicts an additional area of Quailbush Scrub, north of Victoria Street on the east side of the Santa Ana River channel. Photo facing north. Corresponds to Photo Point 2.

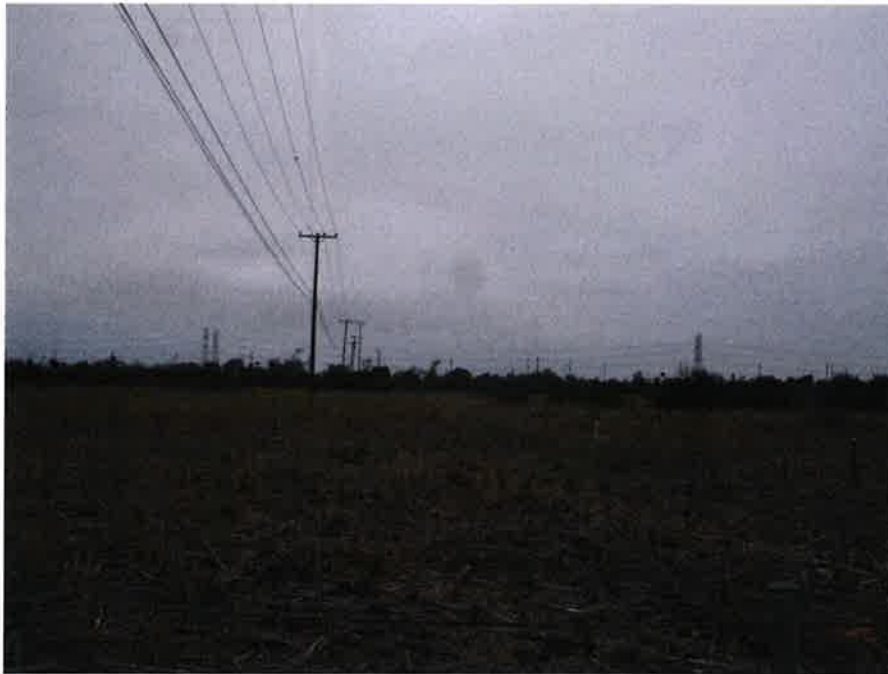
Photo 4. Photo shows an area of Disturbed vegetation community under some power lines on the Project site. Photo facing west.

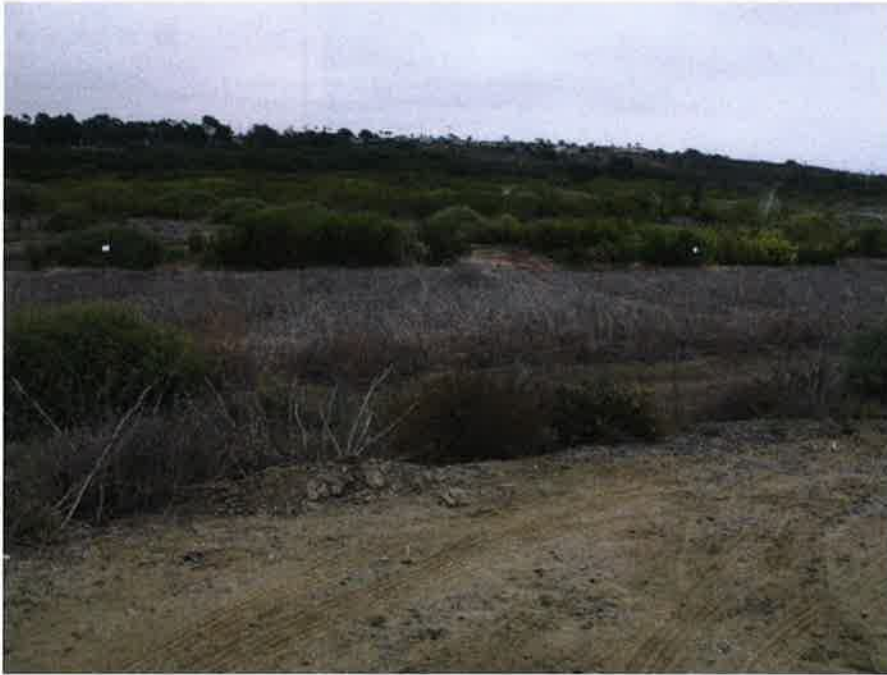
Photo 7. Photo depicts an area of Disturbed Quailbush Scrub toward the center of the Project site. Photo facing east. Corresponds to Photo Point 6.

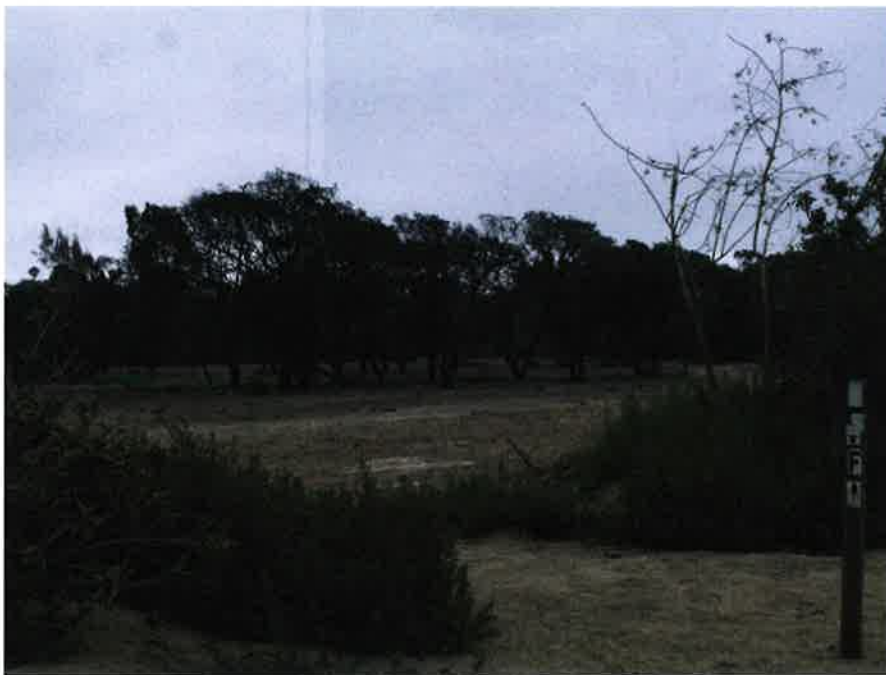
Photo 10. Photo depicts some burned vegetation on the Project site. Photo facing south. Corresponds to Photo Point 4.

In the northern portion of the Park, the vegetation transitions to a drier habitat type dominated by mule fat and coyote brush. Many of the installed sycamore trees appear to be doing well, but also, portions of the northern area have not recovered since the last burn. Restoration efforts have been initiated on site, but many areas have failed due to a lack of water and an over-abundance of weeds.
